Report No. FAA-RD-80-10

EVALUATION OF ADVANCED NON-DESTRUCTIVE INSPECTION METHODS FOR AIRCRAFT TIRES

Donald D. Ewing
B F Goodrich Co.
Research and Development Center
9921 Brecksville Road
Brecksville, Ohio 44141

February 1980

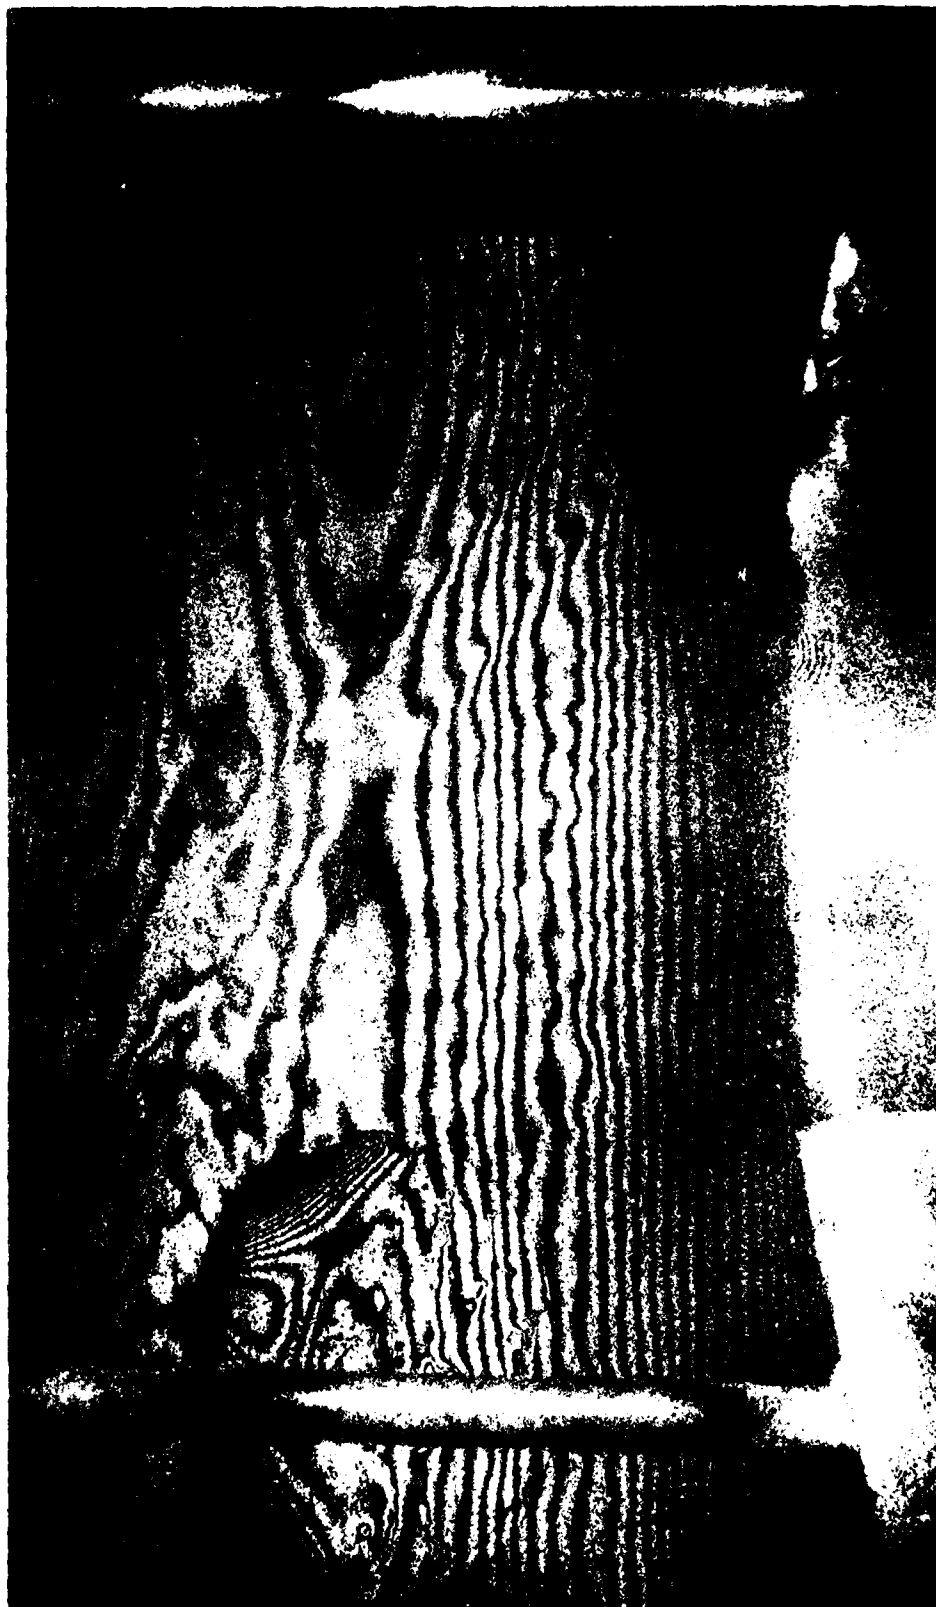
FIGURE 28. HOLOGRAM, SECOND QUADRANT, TIRE NO. N66-0773, #2.

Figure 28 is the second quadrant of tire No. N66-0773, #2, an R7(seven retreads) tire by a different manufacturer. Notice the closeness of the fringe lines as compared to the previous new tire holograms. The oval outline to the left is a balance pad which has some tiny separations between pad and tire liner. No separations are visible in the tire but notice the upper left to lower right line of fringe aberrations which indicates a loose ply splice at an unknown ply position.

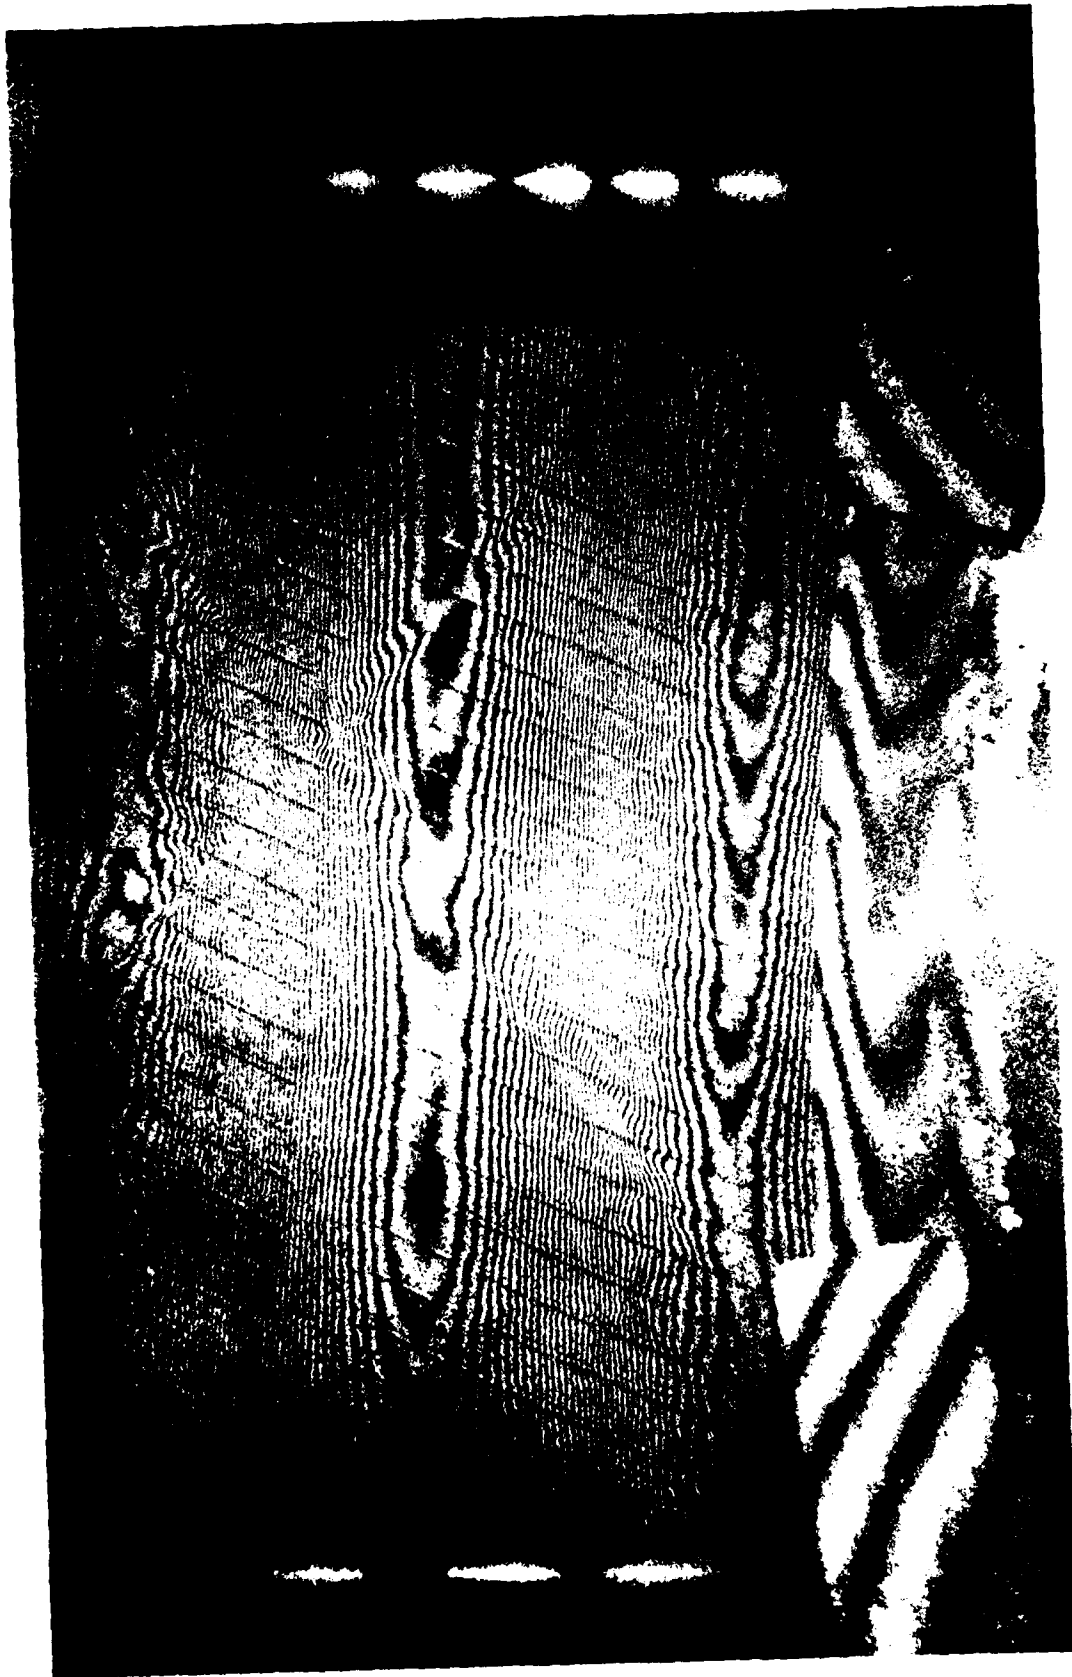
FIGURE 29. HOLOGRAM, FOURTH QUADRANT, TIRE NO. N66-0773, #4.

Figure 29 is the fourth quadrant of tire No. N66-0773, #4, an R5 tire. Again notice the close fringe lines in a used tire and the diagonal fringe aberrations of two loose splices which actually cross (although perhaps not in consecutive ply layers). Separations sometimes develop at these cross-over points or where the loose splice crosses the shoulders.

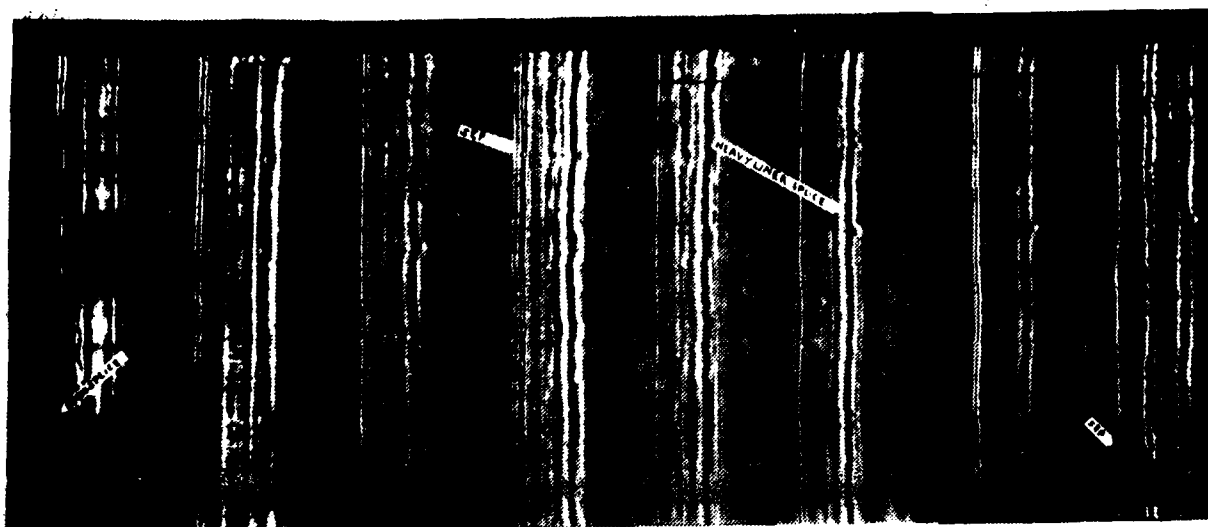
N88-7902

N 88 7902 - This was a retreaded tire marked RI. The information received with the tire indicated 4 separations. Analysis of ultrasonic data showed six areas having possible separations and two areas in which splices could be questioned. In three places the ultrasonic data and the data furnished with the tire agree.
